# 2022 Pakistan Flood: Report on the Damage Assessment of Cultural Heritage in Sindh Province

February 2024

Japan Consortium for International Cooperation in Cultural Heritage

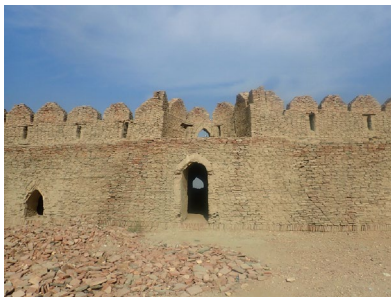
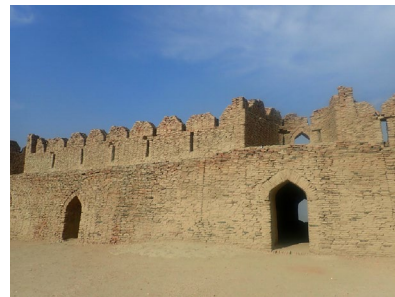
Fig.5 Target structure(Kot Diji Fort)

The target structure is the castle wall in the top area shown in Fig. 5, with a similar structural form, the east brick wall with less damage and the west brick wall with more damage. The locations of the velocity meters in each case are shown in Fig. 6: Ch1 was placed on the ground surface, Ch2 and Ch4 were placed on the west brick wall, which is more damaged, and Ch3 and Ch6 were placed on the east brick wall, which is less damaged, and the north-south direction was measured in CASE 1 and the east-west direction in CASE 2, respectively.

The Fourier spectral ratios are shown in Fig. 7 for each measurement case. In the north-south direction, both brick walls have a common peak around 8.3 Hz, indicating that they are vibrating in unison, but the amplitude is larger on the west brick wall, which is more damaged. In the east-west direction, the east brick wall, which was less damaged, showed a common peak at around 10 Hz, indicating that the brick wall was vibrating as one unit, but the west brick wall, which was more damaged, showed no common peak. This may be due to the fact that the edge of the brick wall where Ch4 was installed was cut off by the damage. In the case of a continuous brick wall such as a castle wall, if the edge of the wall is cut off due to damage, the wall loses stability, and it is important to take countermeasures against this.

(a) West side (Major damage)

(b) East side (slightly damaged)

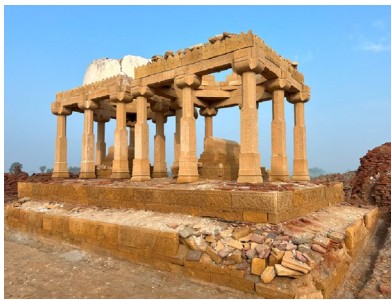
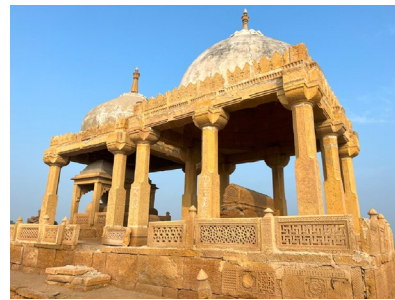
Fig.11 Target structure(Quba Mir Shahdad Talpur)

The target structure is the eight-pillared domed building of Quba Mir Shahdad Talpur shown in Fig. 11, with a similar structural form with more damage to the east side stone structure and less damage to the west side stone structure. The locations of the velocity meters in each case are shown in Fig. 12. In the east side stone structure, where damage was greater, Ch 1 and Ch 2 were installed at ground level, and Ch 3, 4, and 6 were installed at diagonal positions at the corner of the rooftop, and measurements were made in the north-south direction in CASE 1 and in the east-west direction in CASE 2. Similar measurements were made on the west side of the stone structure, which was less damaged, in the north-south direction in CASE 3 and in the east-west direction in CASE 4.

The Fourier spectral ratios are shown in Fig. 13 for each measurement case. In both the north-south and east-west directions, peaks are observed around 4.9 Hz for the east stone structure with large damage and around 5.9 Hz for the west stone structure with small damage, respectively. The peak frequency was higher for the less damaged stone structure on the west side, and the fact that no significant damage was observed at the columns suggests that the loss of the integrity of the building due to the loss of the dome section may have had an effect. From the above, the stability of a stone structure with a domed rooftop is greatly affected by damage to the dome section.

(a) East side(Major damage)

(b) West side (slightly damaged)

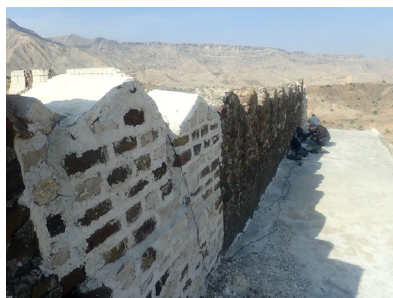
Fig.14 Target structure (Ranikot)

The subject structure is a part of the castle wall shown in Fig. 14, with a similar structural form, the east stone wall having been plastered by later restoration, and the west stone wall in its original condition. The locations of the velocity meters are shown in Fig. 15: Ch1 was placed on the ground surface, Ch2 on the east stone wall after restoration, and Ch3 and Ch4 on the original west stone wall, and the north-south direction was measured.

The Fourier spectral ratios are shown in Fig. 16. A common peak is seen around 14 Hz for the east stone wall after restoration and around 11 Hz for the original stone wall. Although the peak frequency is higher for the restored stone wall, it appears to vibrate separately from the original stone wall, possibly due to the loss of unity as a castle wall. The above indicates that it is important to unify the restoration methods used for the continuous stone walls such as castle walls, because they lose their integrity if different restoration methods are used at different locations.

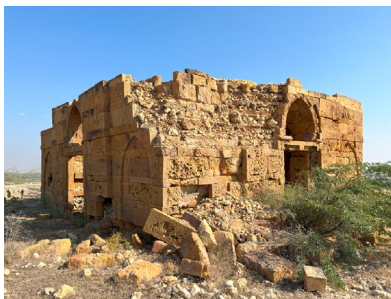
Fig.17 Target structure (Makli)

The target structure is the stone structure of Makli shown in Fig. 17, with the dome portion missing and some walls collapsed. The locations of the velocity meters in each case are shown in Fig. 18: Ch 1 was placed on the ground surface, and Ch 2, 3, 4, and 6 were placed at the diagonal positions of the rooftop corners, and the north-south direction was measured in CASE 1 and the east-west direction in CASE 2, respectively.

The Fourier spectral ratios are shown in Fig.19 for each measurement case, with peaks around 12 Hz for Ch 2 and Ch 3, and around 11 Hz for Ch 4 and Ch 6, indicating that the peak frequencies differ between the structures in both the east-west and north-south directions. This is thought to be due to the loss of the integrity of the building due to the loss of the dome section. From the above, the stability of a masonry structure with a domed rooftop is greatly affected by damage to the dome section.

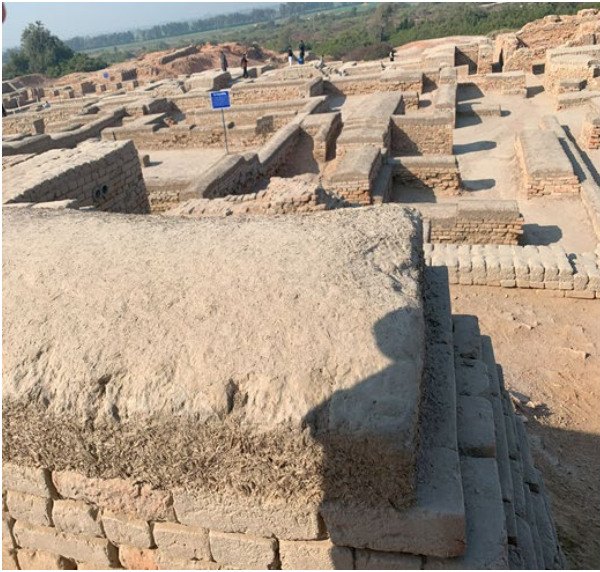
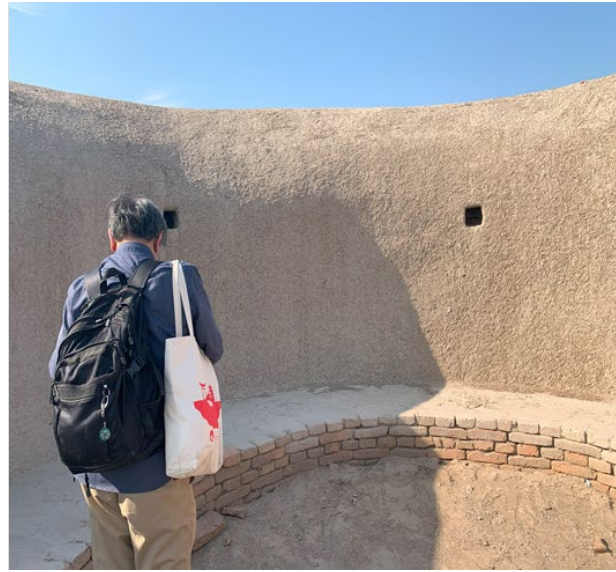
Fig.5 Mud slurry and mud capping works to protect the ruins (i.e. wall and stupa dome) from extreme climatic/weather conditions.

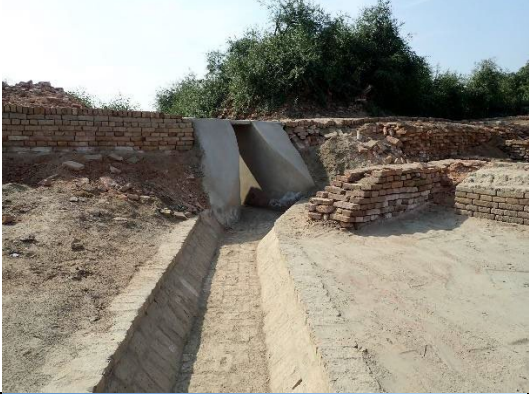
<p>Fig.2 Moenjodaro HR area. There are complex undulations and the remains of dwellings with difficult drainage exist.</p>

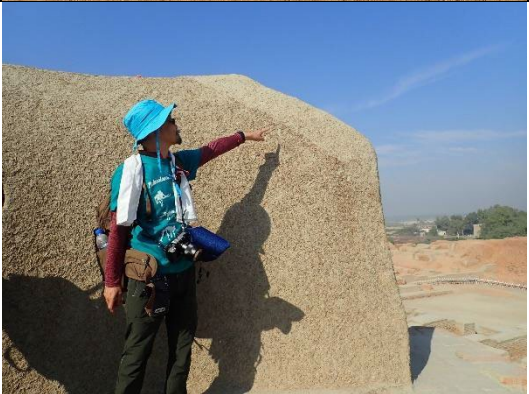
<p>Fig.4 Brick wall with progressive salt weathering. Salt weathering is in progress throughout the entire site, and research on countermeasures is needed.</p>

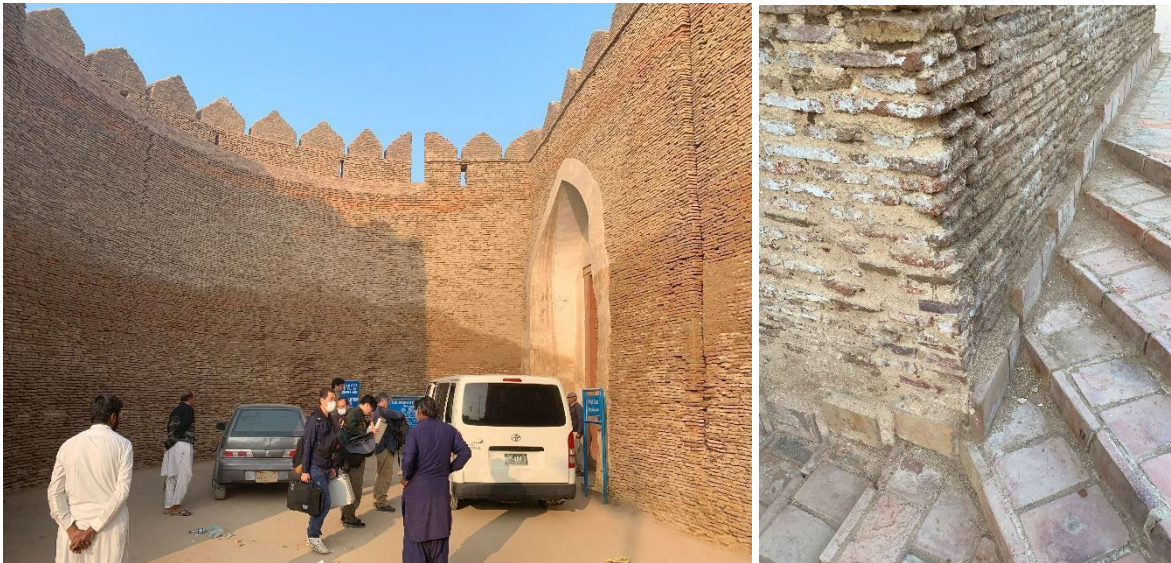
Fig. 2 Left image depicts the entrance to fort and right image depicts the status of the boundary wall near of the entrance

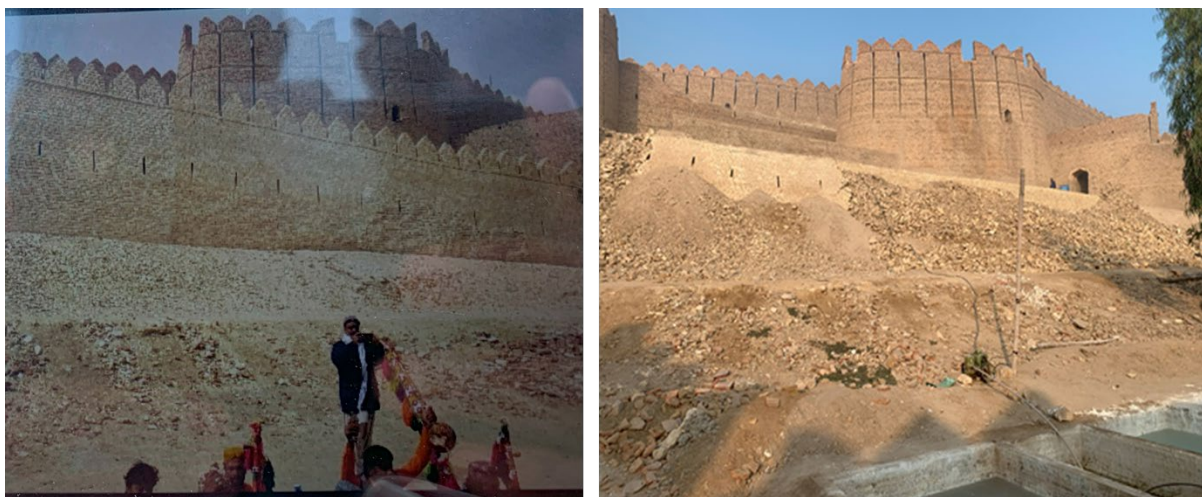
Fig. 3 Left image depicts the previous condition of the boundary wall (source: Bilawal) right image depicts the status of the boundary wall near of the entrance

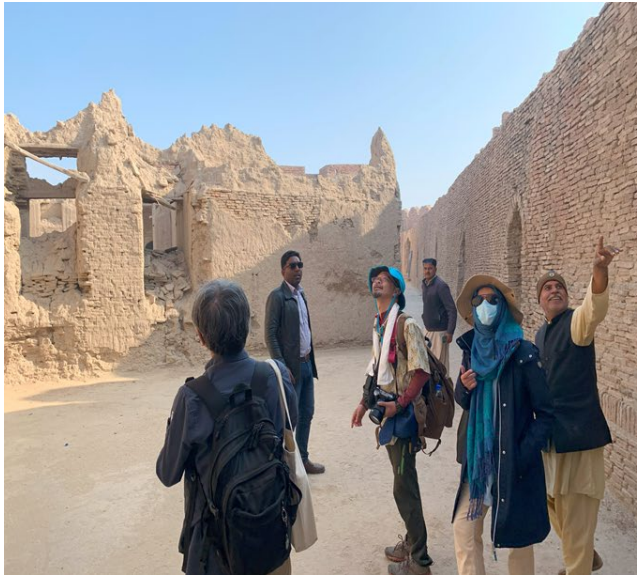
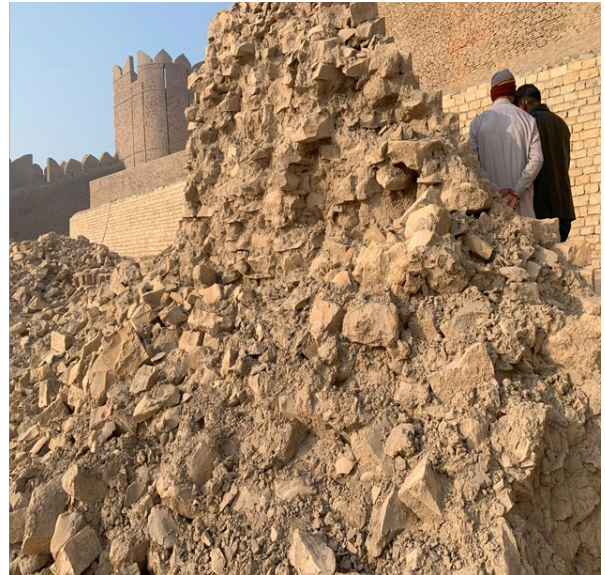
Fig. 4 Status of the walls and structures after the damage

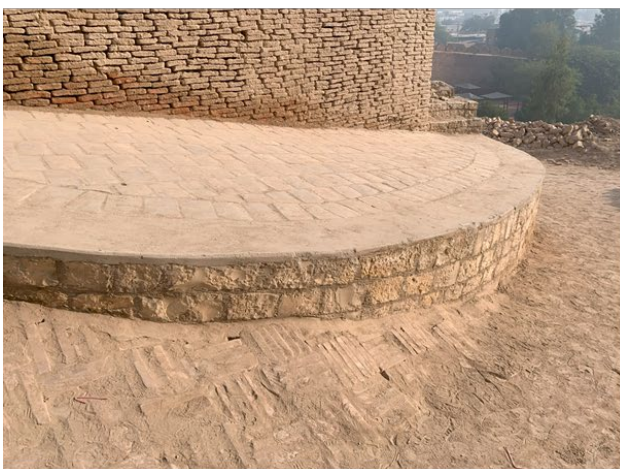
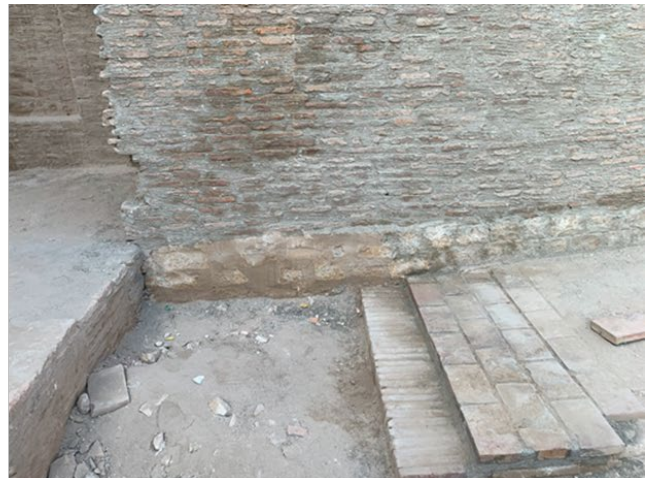
Fig. 5 On-going restoration works of pathways/decks and walls

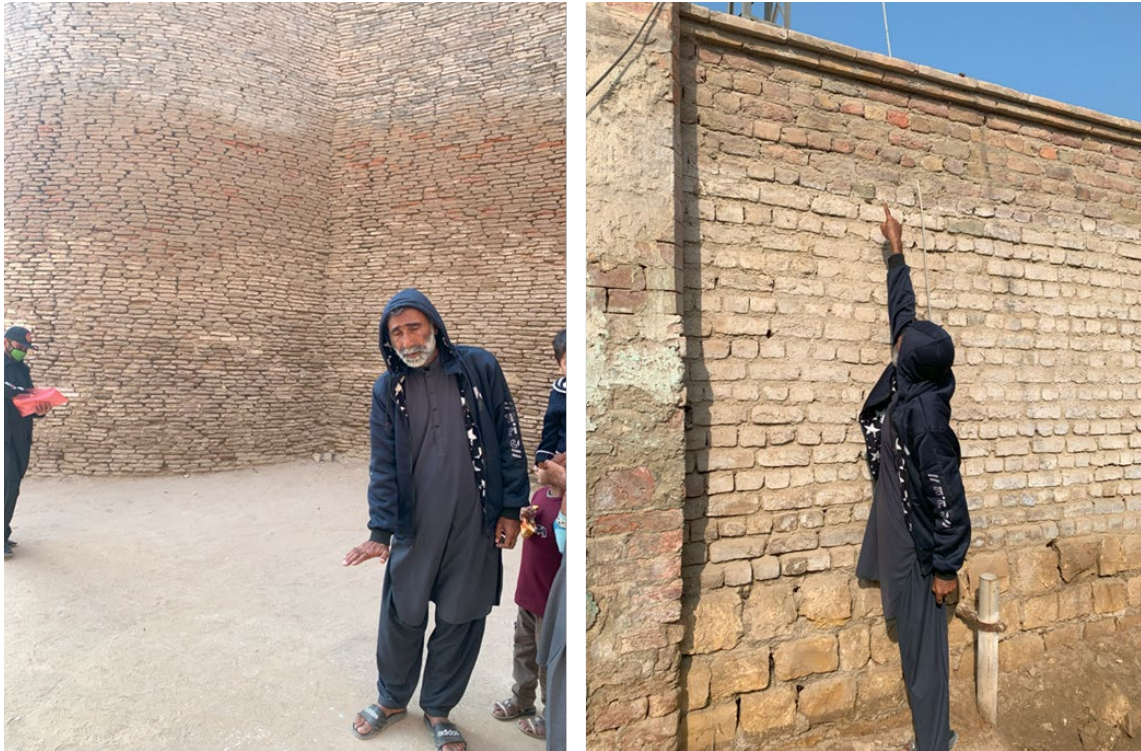
Fig. 6 Left image shows the water level near the fort entrance and right depicts the water level in the city area during Aug. 2022 flooding pointed out by a fort staff previous

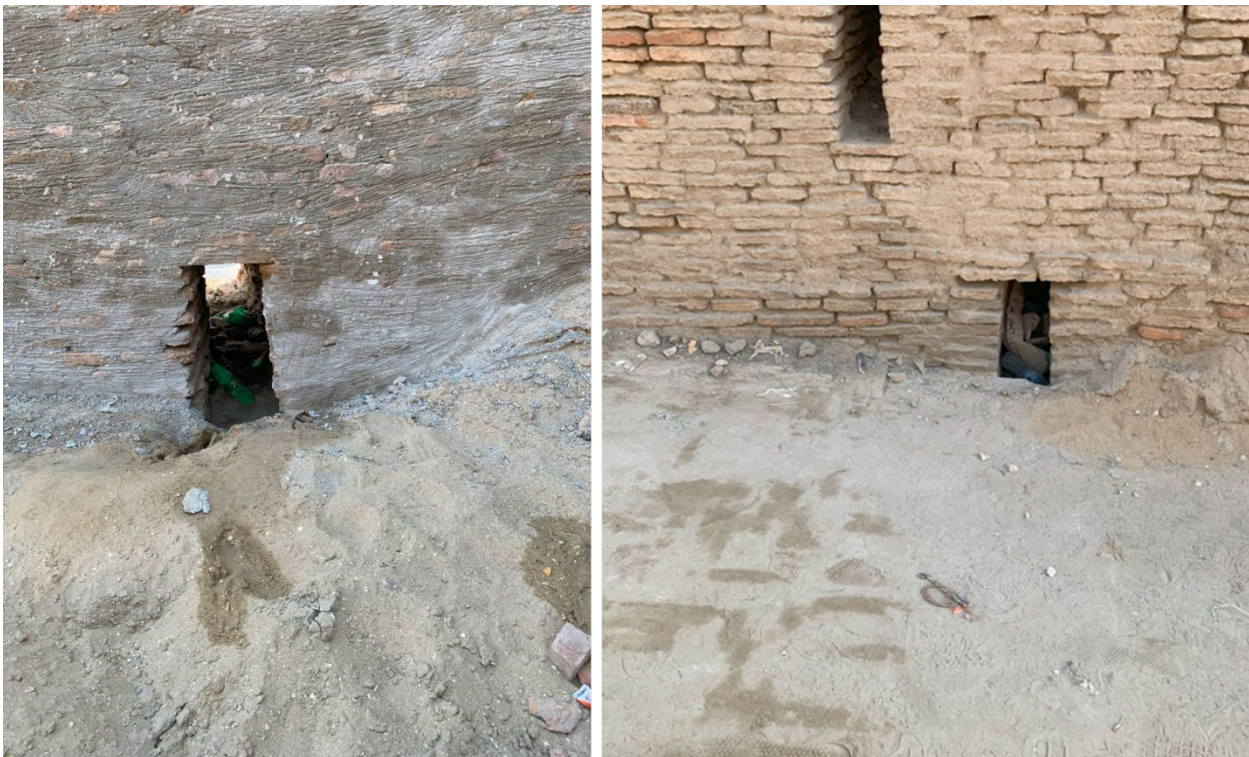
Fig. 7 The existing conditions of the drainage system

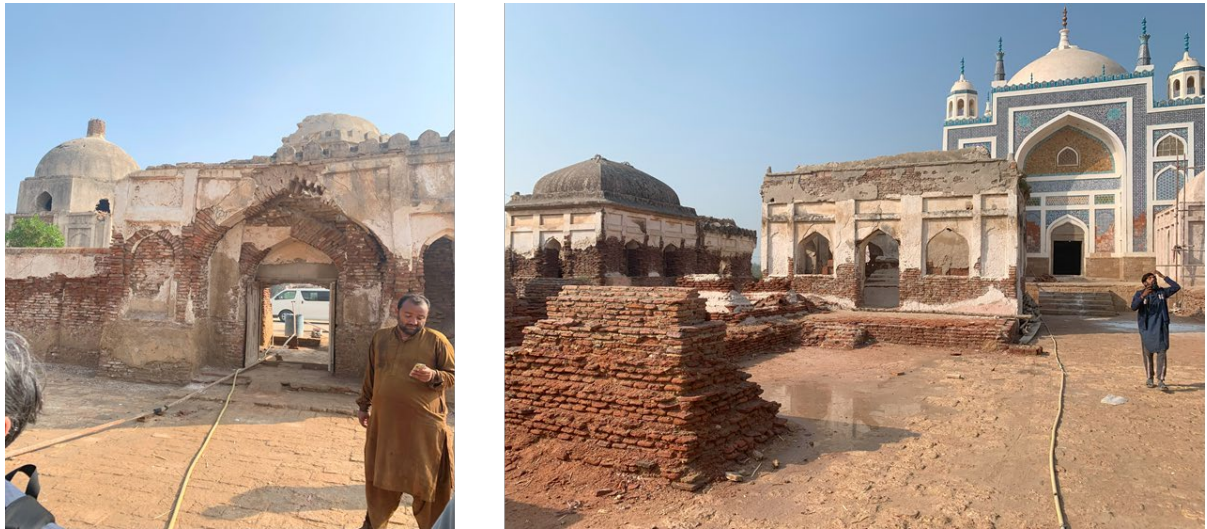
1. Pre-existing weaknesses in the gate, dome, and wall due to aging
2. Heavy Rainwater splash and other climatic conditions has resulted in hollowing out of masonry, loss of bonding mortar, and weakening the walls due.
3. Hydration/dampness in walls due to surrounding climatic conditions that is continuously weakening the walls and structures.

Fig. 2 Status of the walls and structures after the damage

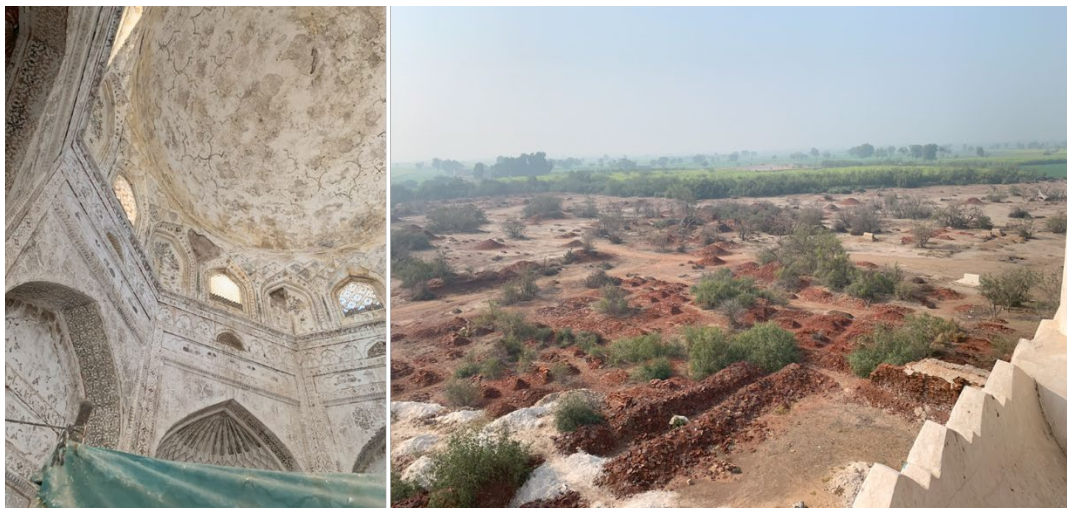
Fig. 3 Cracking on the main dome and damages to the surrounding graves

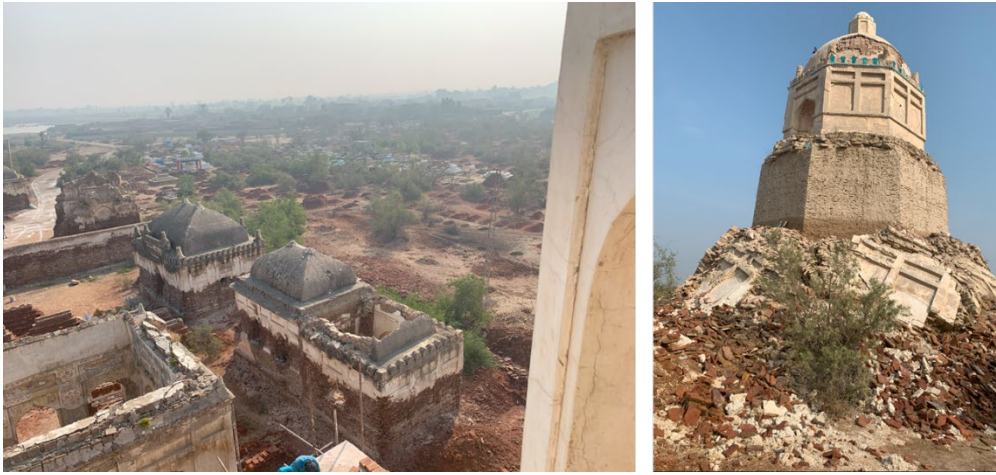
Fig. 4 Damage status of the domed structures/tombs

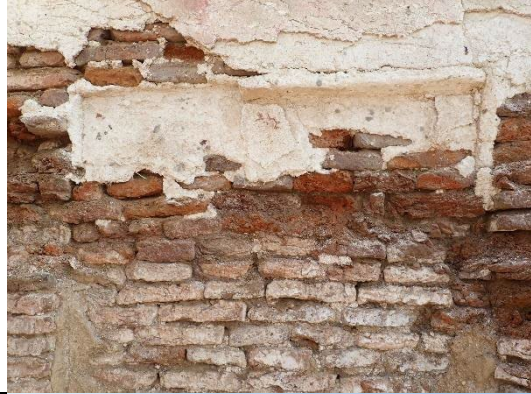
Fig.7 Partial brickwork collapse is observed on the south face of the north wall.

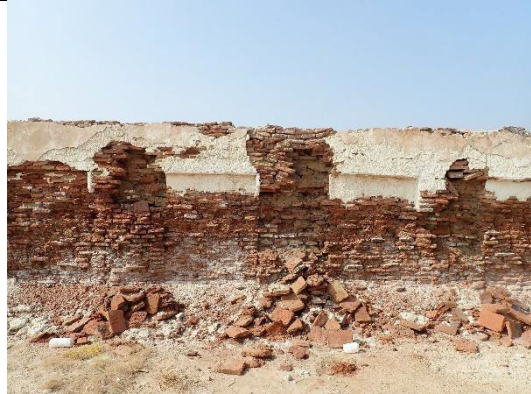
Fig.8 On the north face of the north wall (opposite side of Fig. 7), salt weathering is observed.

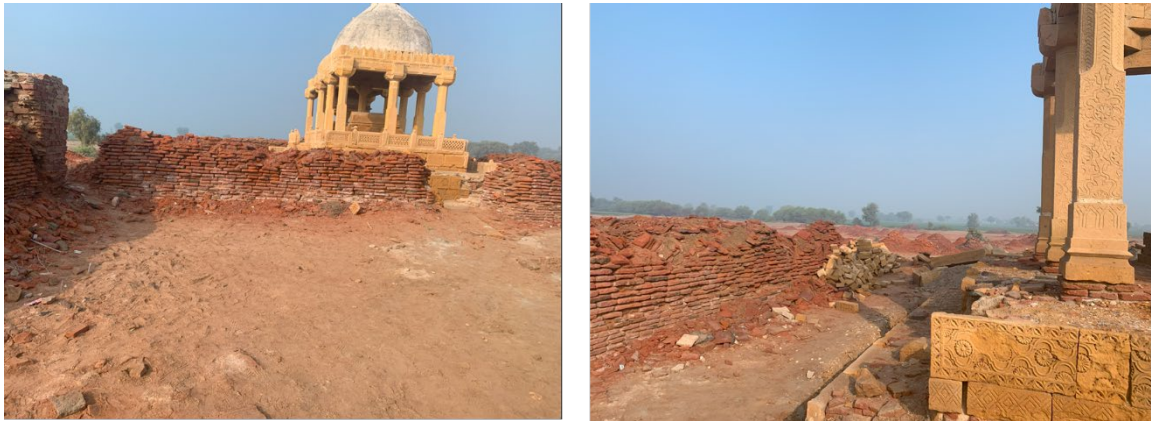
1. Pre-existing weaknesses in the Quba dome and wall due to aging
2. Heavy Rainwater splash and strong rain drop impact force as well as other climatic conditions has resulted in hollowing out of masonry, loss of bonding mortar, and weakening the walls due.
3. Pre-existing high degree of hydration/dampness in walls due to surrounding climatic conditions weakening the walls and structures.

Fig. 2 Status of the walls and structures after the damage

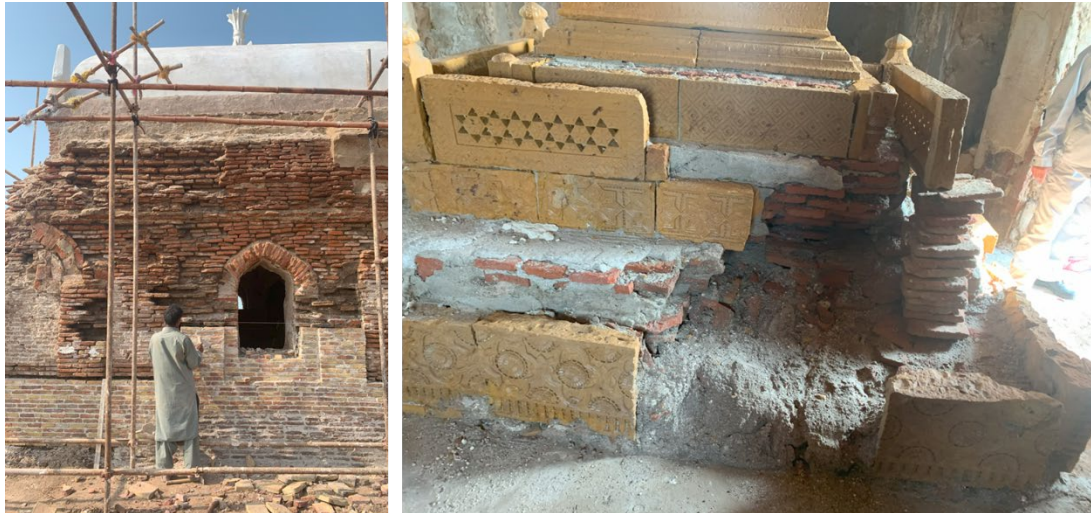
Fig. 3 Outer renovation and restoration works and damages to the grave structures due to dampness

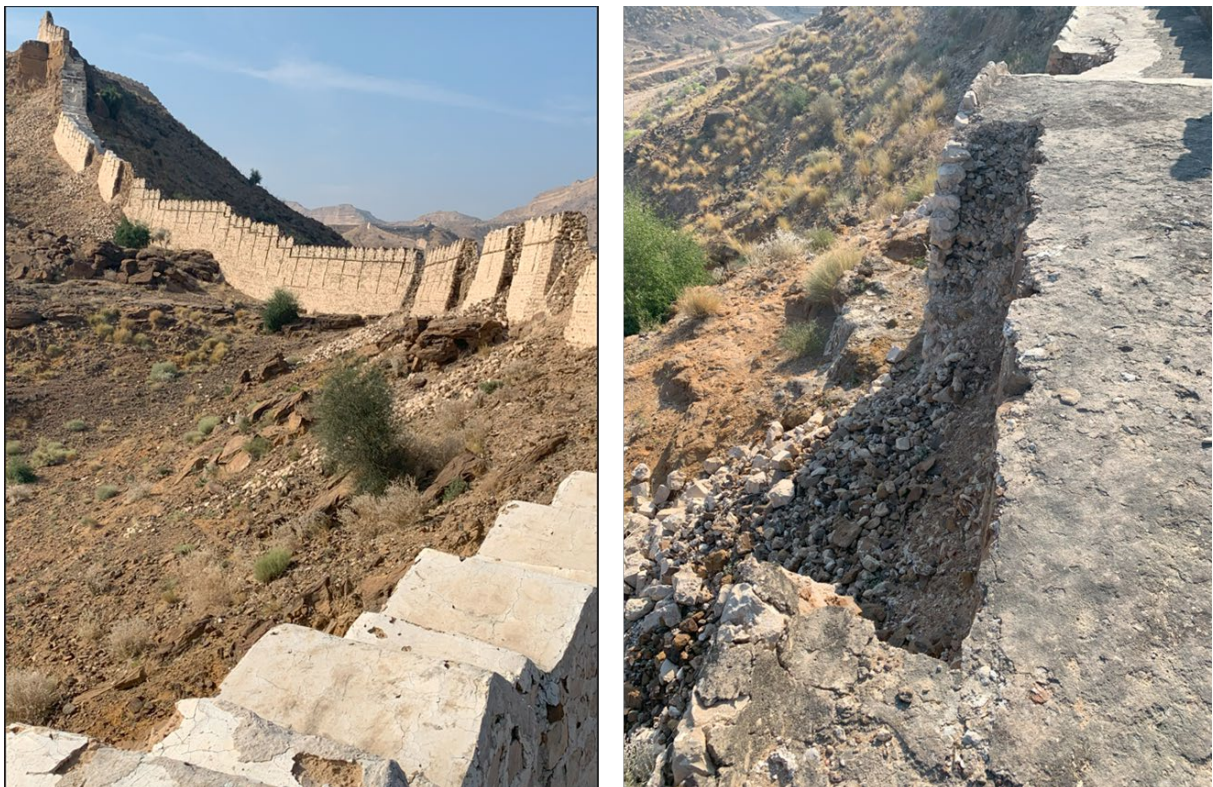
1. pre-existing weaknesses in the wall and structures due to aging
2. Cracking of the lime-mortar protection layer and allowing water to intrude to the wall core that was made of mud and stones.
3. Poor surface drainage and rainwater splash has resulted in hollowing out of the stone wall and weakening the base of the walls due to water flow along the pathways.

Fig. 1 Damages to walls and basements

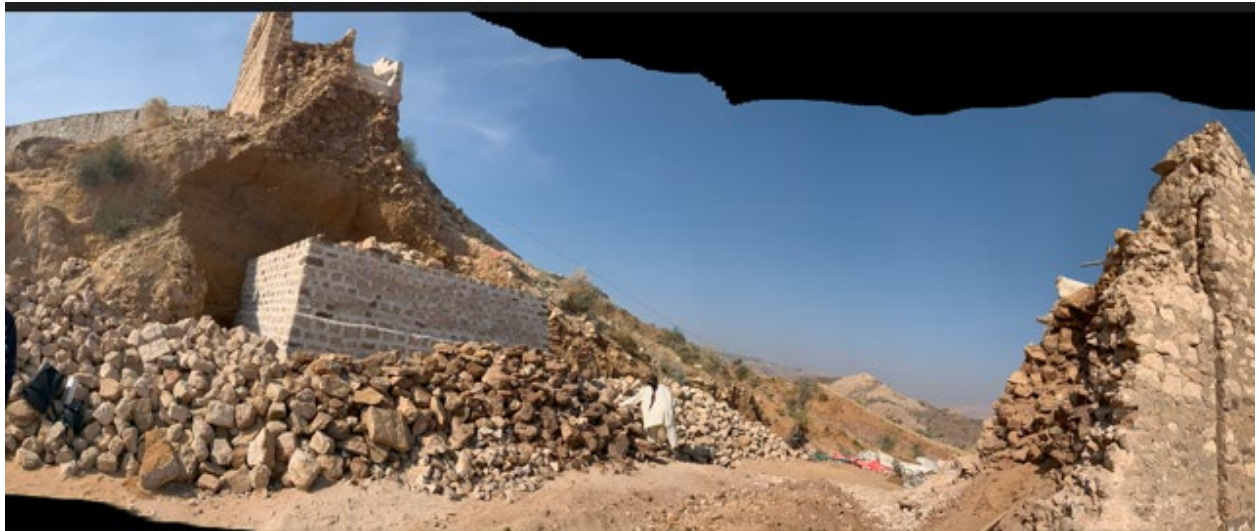
Fig. 2 Collapse of the Shah-Pere Gate and status of reconstruction

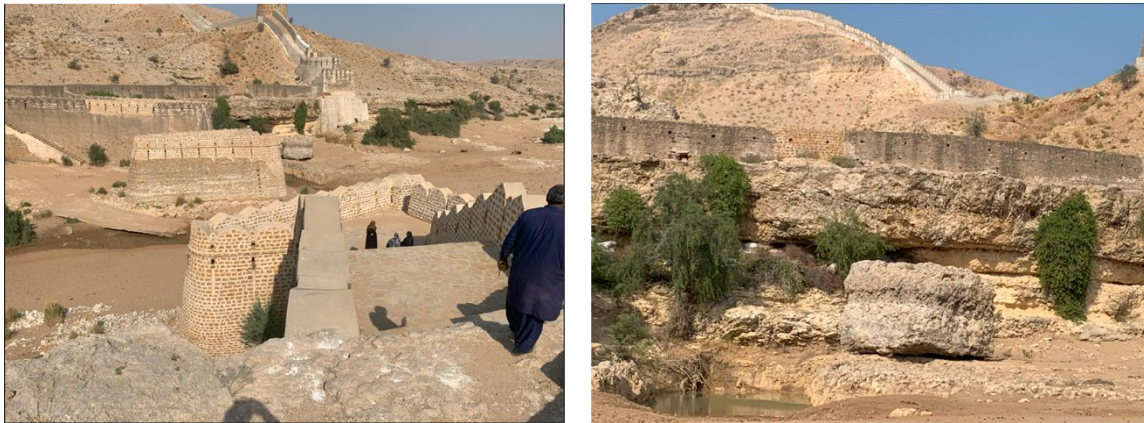
Fig. 3 Flow path of Sann river near the main gate and the eroded condition of the wall foundation and supported by sand bags

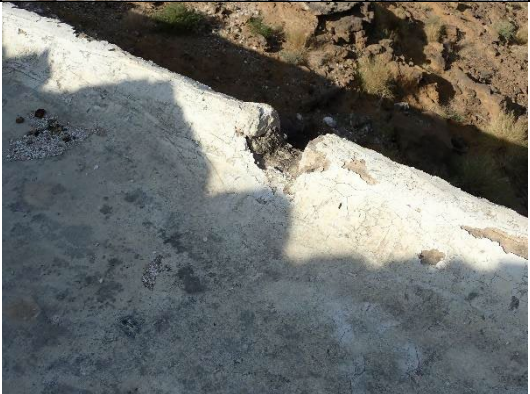
<p>Fig.3 Collapsed condition of the castle wall. Scattered white limestone from the collapsed area indicates that the area had been restored.</p>

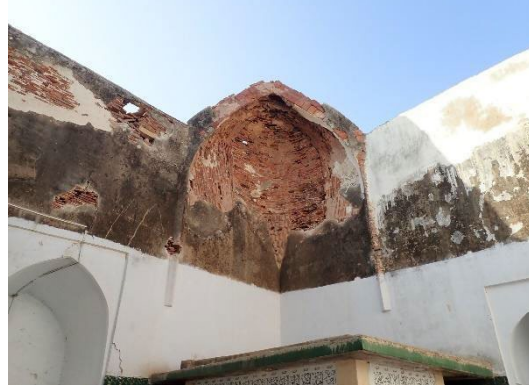
Fig.3 The building is mainly constructed of stonework; strong rainfall during the flood of 2022 caused the building to collapse.

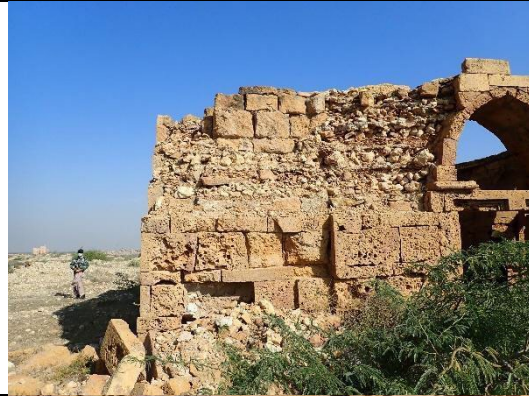
Fig.6 Salt weathering observed in the lower part of stonework structures.
