# 2022 Pakistan Flood: Report on the Damage Assessment of Cultural Heritage in Sindh Province

February 2024

Japan Consortium for International Cooperation in Cultural Heritage

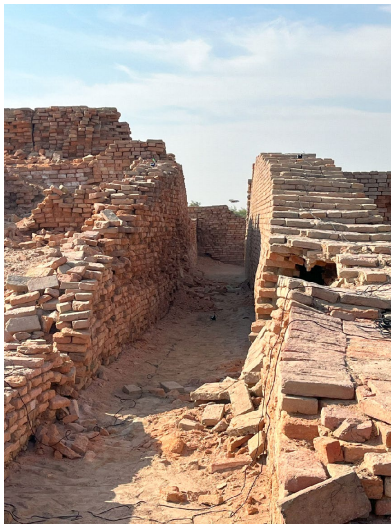
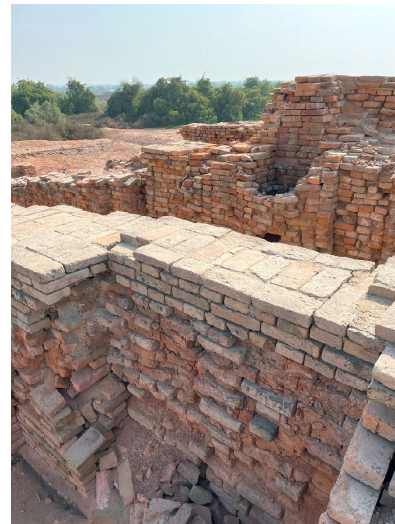
Fig.2 Target structure (Moenjodaro)

The target structures are the remains of the HR area shown in Fig. 2. Across the passage, the brick wall on the north side is less damaged and the brick wall on the south side is more damaged. The locations of the velocity meters in each case are shown in Fig. 3: Ch1 was placed on the ground surface, Ch2 and Ch4 were placed on the south brick wall, which is more damaged, and Ch6 was placed on the north brick wall, which is less damaged, and the north and south directions were measured in CASE1 and CASE2 and in CASE3, respectively.

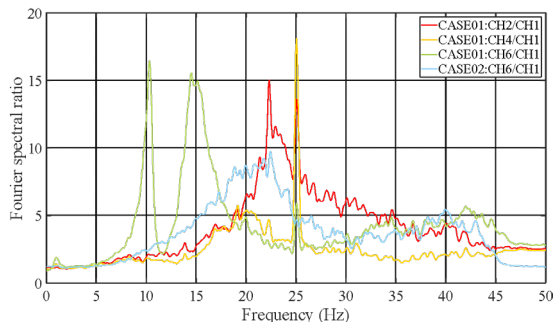
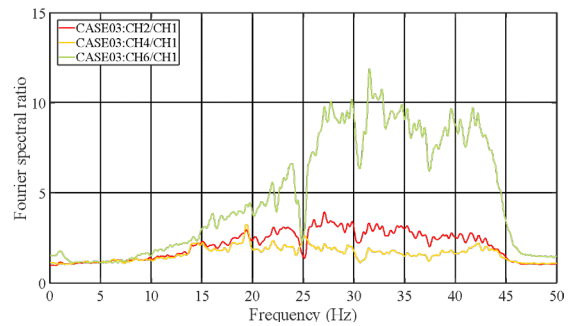
Fig.4 Measurement results (Moenjodaro)

The Fourier spectral ratios are shown in Fig. 4 for each measurement case. In the north-south direction, a peak was observed around 22 Hz for the south brick wall with large damage and around 10 Hz for the north brick wall with small damage, while no clear peak was observed in the east-west direction. The peak frequency was lower for the brick wall on the north side, which was less damaged, but this may be due to the support condition of the brick wall rather than the size of the damage, since there was no brick wall orthogonal to the edge of the brick wall where the sensor was placed in Ch6 of CASE 1. This indicates that the stability of a brick wall depends not only on the size of the damage, but also on the existence of a brick wall orthogonal to the wall.

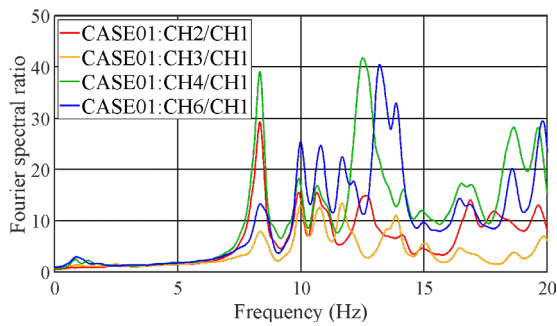
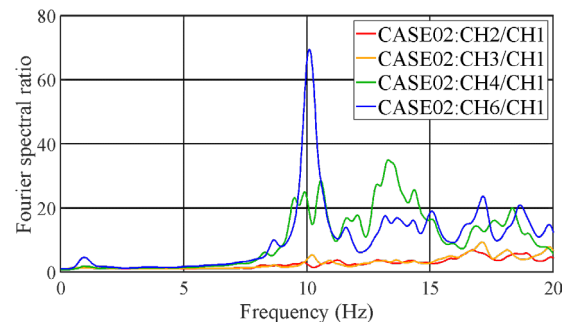
Fig.7 Measurement results(Kot Diji Fort)

The Fourier spectral ratios are shown in Fig. 7 for each measurement case. In the north-south direction, both brick walls have a common peak around 8.3 Hz, indicating that they are vibrating in unison, but the amplitude is larger on the west brick wall, which is more damaged. In the east-west direction, the east brick wall, which was less damaged, showed a common peak at around 10 Hz, indicating that the brick wall was vibrating as one unit, but the west brick wall, which was more damaged, showed no common peak. This may be due to the fact that the edge of the brick wall where Ch4 was installed was cut off by the damage. In the case of a continuous brick wall such as a castle wall, if the edge of the wall is cut off due to damage, the wall loses stability, and it is important to take countermeasures against this.

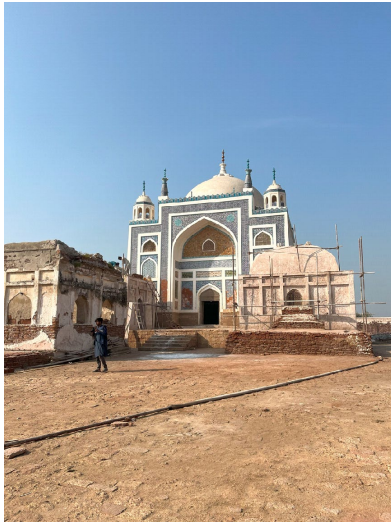
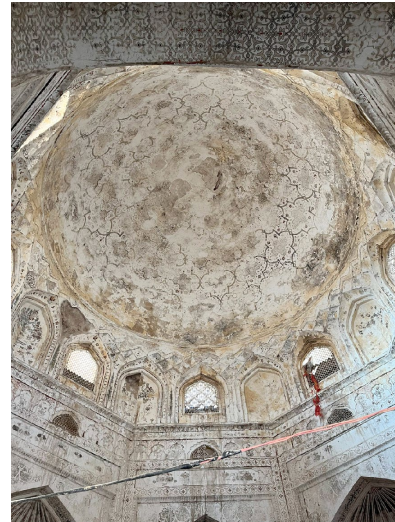
Fig.8 Target structure(Mian Noor Muhammad Kalhoro Graveyard)

The target structure is the dome-shaped building of Mian Noor Muhammad Kalhoro Graveyard shown in Fig.8, with the exterior walls restored but with cracks remaining in the interior. The locations of the velocity meters in each case are shown in Fig. 9: Ch1 was placed at ground level, and Ch2, 3, 4, and 6 were placed at the center of each of the four sides of the rooftop floor, and the north-south and east-west directions were measured in CASE 1 and CASE 2, respectively.

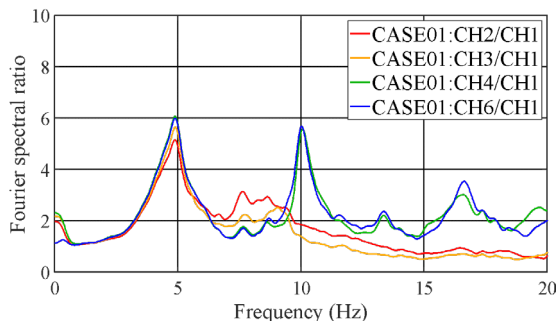
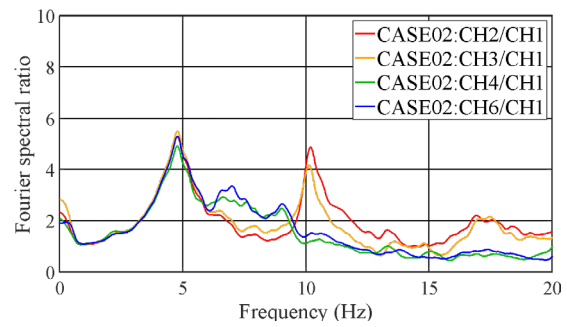
Fig.10 Measurement results (Mian Noor Muhammad Kalhoro Graveyard)

The Fourier spectral ratios are shown in Fig. 10 for each measurement case. The peaks in both the north-south and east-west directions are around 4.9 Hz and 10 Hz, respectively, and it is inferred that the former is the natural frequency of the in-plane direction of the wall and the latter is the natural frequency of the out-of-plane direction of the wall. Normally, the natural frequencies of out-of-plane walls are lower than those of in-plane walls, but in this building, the relationship is reversed. This may be due to the fact that the out-of-plane vibration is restrained by the arch effect of the dome. The above indicates that the stability of the walls of a building with a dome-shaped rooftop is greatly affected by damage to the dome section.

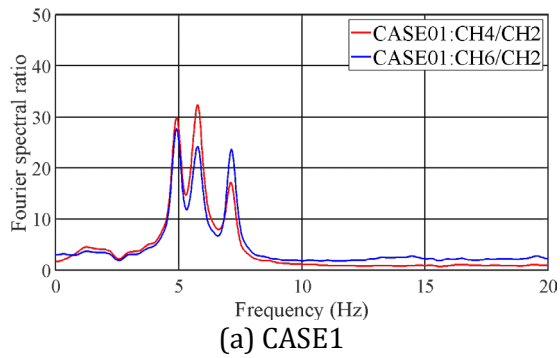
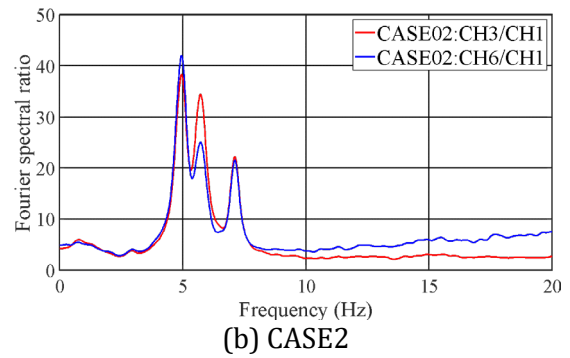
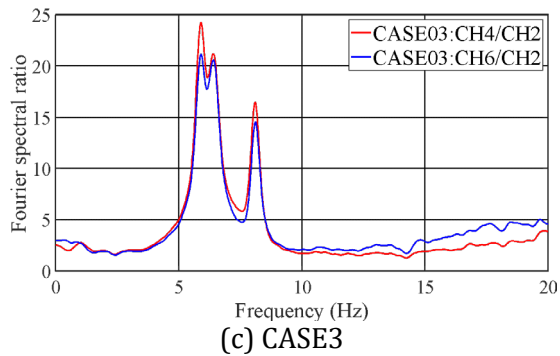
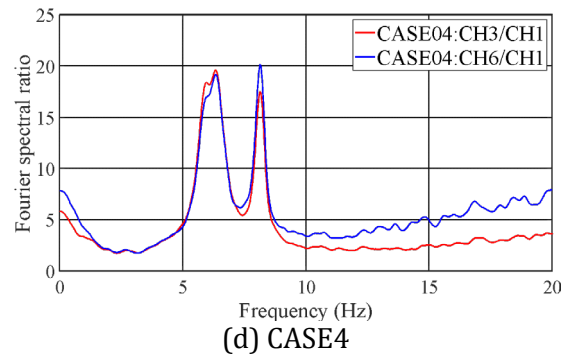
Fig.13 Measurement results(Quba Mir Shahdad Talpur)

The Fourier spectral ratios are shown in Fig. 13 for each measurement case. In both the north-south and east-west directions, peaks are observed around 4.9 Hz for the east stone structure with large damage and around 5.9 Hz for the west stone structure with small damage, respectively. The peak frequency was higher for the less damaged stone structure on the west side, and the fact that no significant damage was observed at the columns suggests that the loss of the integrity of the building due to the loss of the dome section may have had an effect. From the above, the stability of a stone structure with a domed rooftop is greatly affected by damage to the dome section.

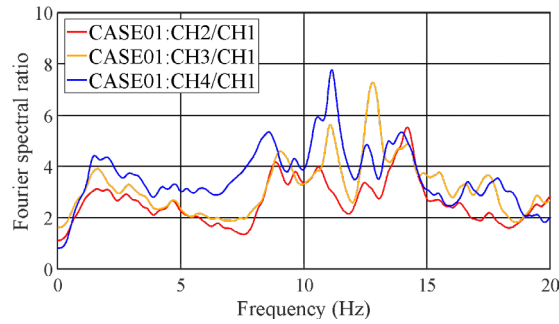
Fig.16 Measurement results(Ranikot)

The Fourier spectral ratios are shown in Fig. 16. A common peak is seen around 14 Hz for the east stone wall after restoration and around 11 Hz for the original stone wall. Although the peak frequency is higher for the restored stone wall, it appears to vibrate separately from the original stone wall, possibly due to the loss of unity as a castle wall. The above indicates that it is important to unify the restoration methods used for the continuous stone walls such as castle walls, because they lose their integrity if different restoration methods are used at different locations.

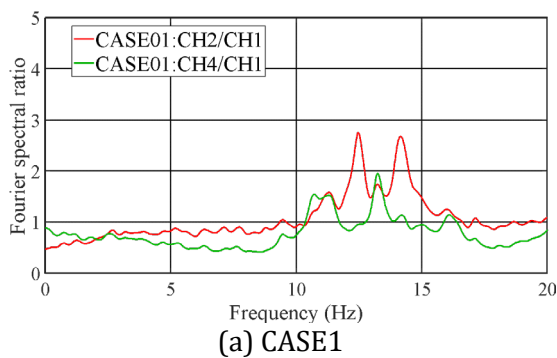
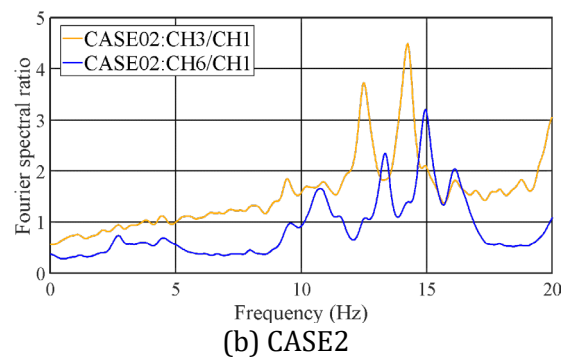
Fig.19 Measurement results(Makli)

The Fourier spectral ratios are shown in Fig.19 for each measurement case, with peaks around 12 Hz for Ch 2 and Ch 3, and around 11 Hz for Ch 4 and Ch 6, indicating that the peak frequencies differ between the structures in both the east-west and north-south directions. This is thought to be due to the loss of the integrity of the building due to the loss of the dome section. From the above, the stability of a masonry structure with a domed rooftop is greatly affected by damage to the dome section.

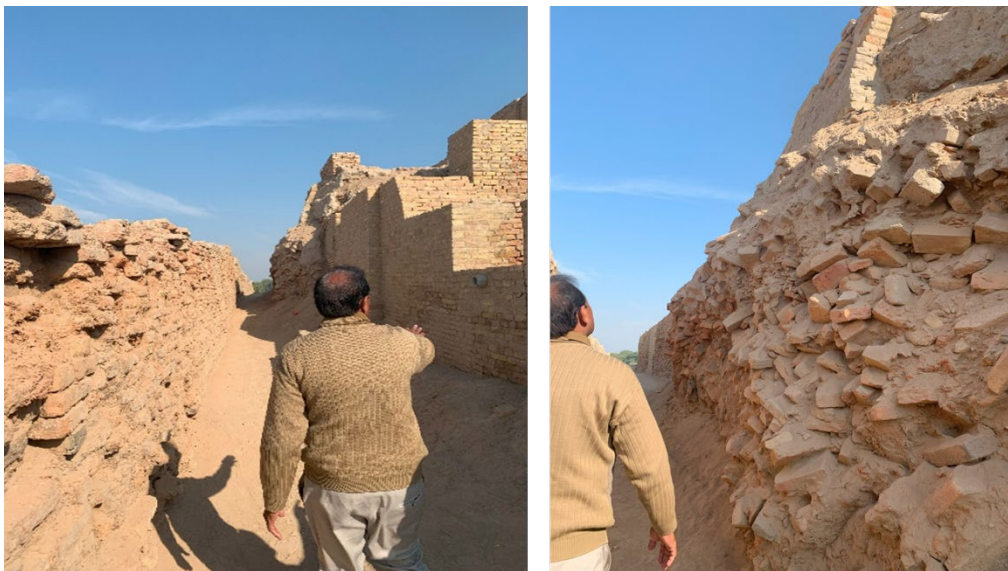
Fig. 3 Left image depicts the status of the ruins and conservation of wall basements using mud and straw and right image depicts the collapse of the structure and wall which need to be restored later with proper care.

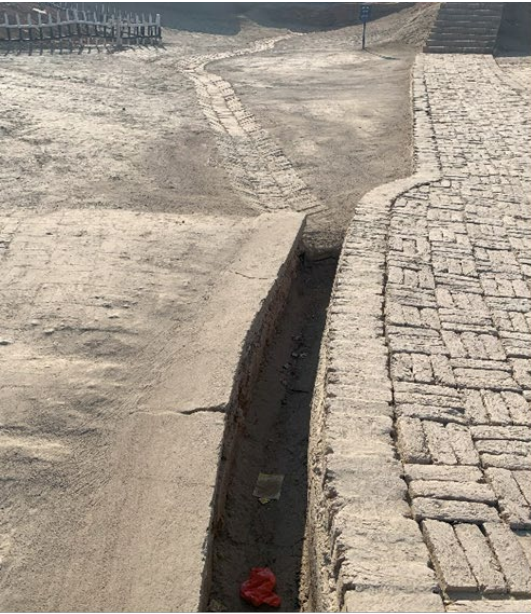
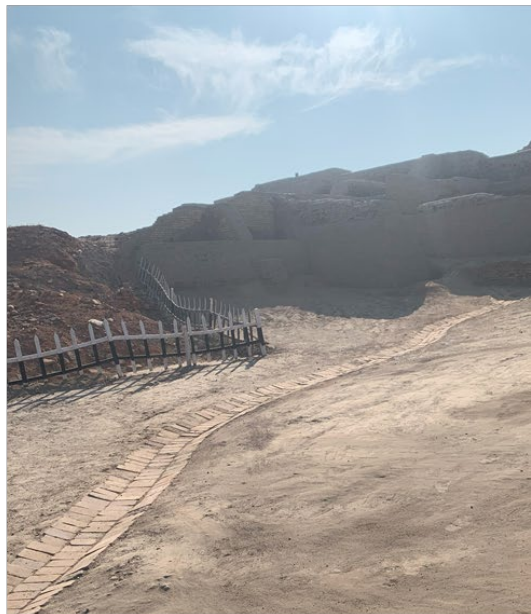
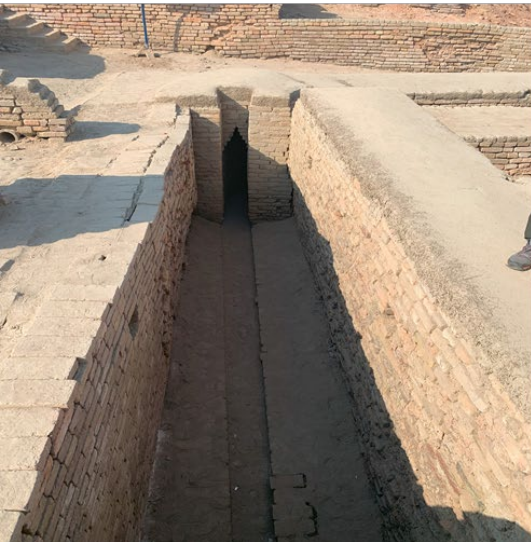
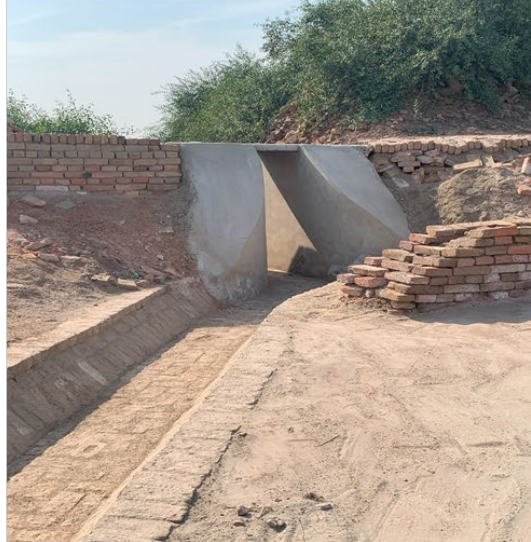
Fig. 4 These photographs were taken at the S.D. and HR area, which depicts the new and old paved/concrete pathway for deep and shallow drainage systems to ease the water flow away from the main structures.

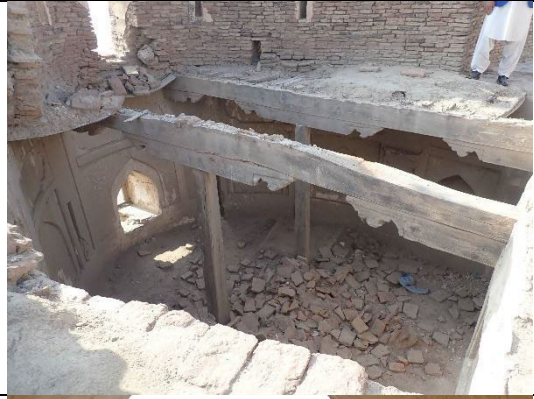
Fig.5 A Bathhouse with collapsed roof.

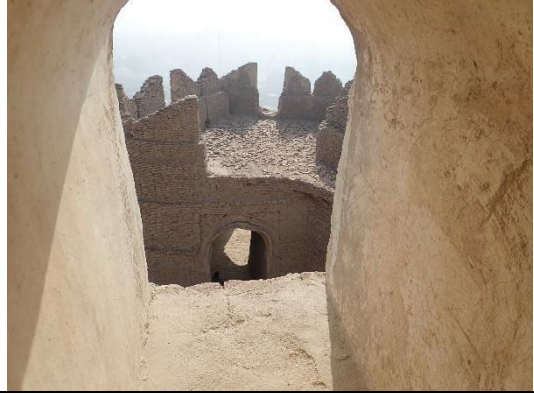
Fig.6 The plaster layer in the roof area at the back of the figure is fragmented and has lost its waterproofing function.

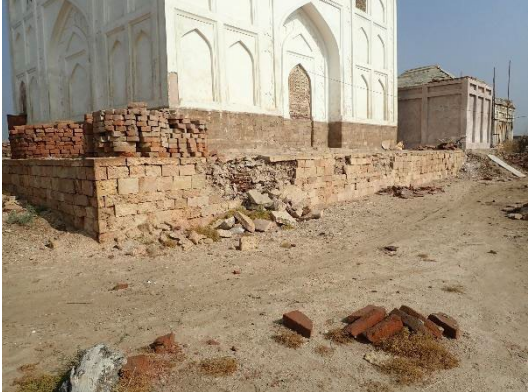
<p>Fig.1 The mausoleum is built on a brick platform decorated with limestone blocks. The platform partially collapsed.</p>

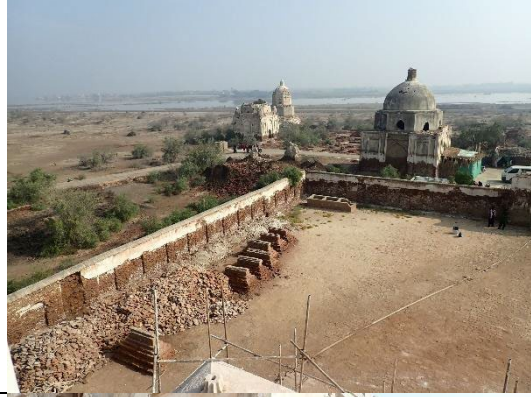
Fig.4 Originally, the eastern side of Mian Noor Muhammad Kalhoro Graveyard was a field area, but it is still submerged.

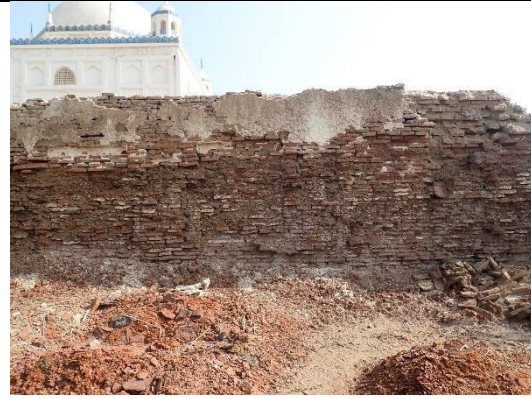
Salt precipitation was partially observed in areas where the brickwork, the main body of the wall, was exposed. One phenomenon observed on the north wall was the collapse of the south face (Fig. 7), while salt precipitation was observed on the north face, which corresponds to the opposite side of the same location (Fig. 8). The ground surface is in a high-water content state and the wall is constantly supplied with water, but on the south face, the surface may be rapidly drying out due to solar radiation during the day and becoming wet again at night, which is repeated. On the other hand, on the opposite side of the same location, water is constantly evaporating on the surface, causing salt to concentrate and crystallize when the temperature and humidity meet the conditions for salt deposition, possibly resulting in salt weathering. The temperature distribution on the north face of a brick tomb in the mausoleum area (Fig. 9) was measured using thermal imaging and a radiation thermometer, showing that the temperature was higher in the upper part of the tomb and also in the lower part where there was sunlight (Fig. 10). The upper part of the tomb is always dry, while the lower part is always wet. In the lower part, the same deterioration phenomenon may have occurred as in the north wall described above. The brick tombs outside of the mausoleum area are also considered to be deteriorating in a similar manner. The reason for the more advanced deterioration outside the mausoleum area than inside the mausoleum area could not be determined enough to be discussed in this survey.

Fig.8 On the north face of the north wall (opposite side of Fig. 7), salt weathering is observed.

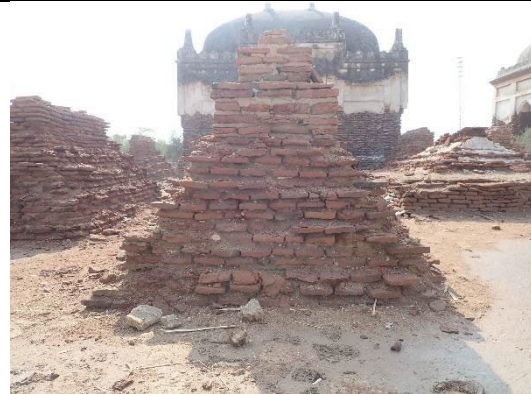
Fig.9 Brick tomb. The condition of the north face is not as severely deteriorated as the east, south, and west faces.

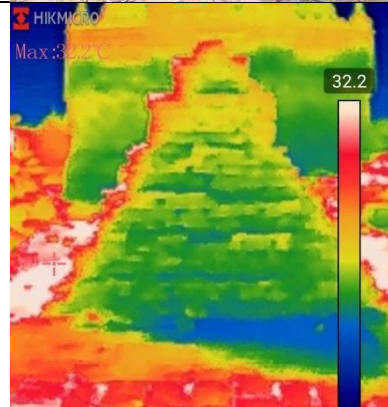
Fig.10 Thermal image of the brick tomb in Fig. 9. A trend toward higher temperatures at the top is observed. The influence of solar radiation and moisture content is considered.

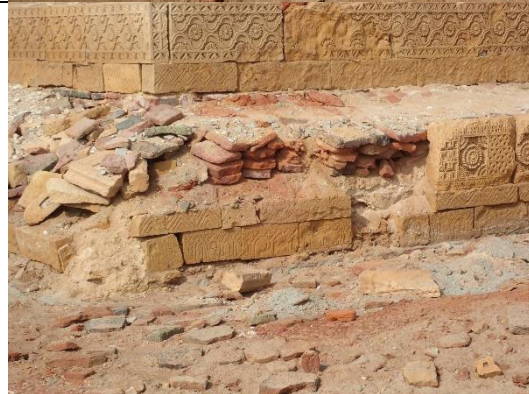
Fig.2 The basement is brickwork, as evidenced by the collapsed sections.

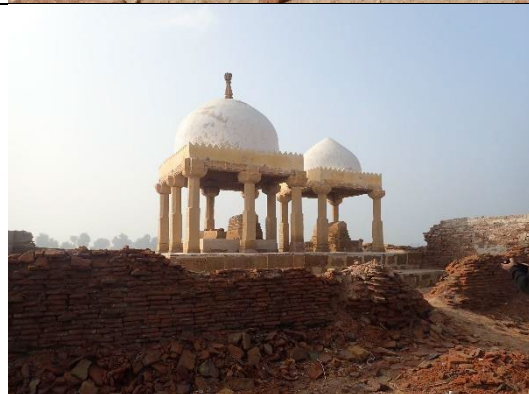
Fig.3 The restored mausoleum which had collapsed in the 2010 flood.

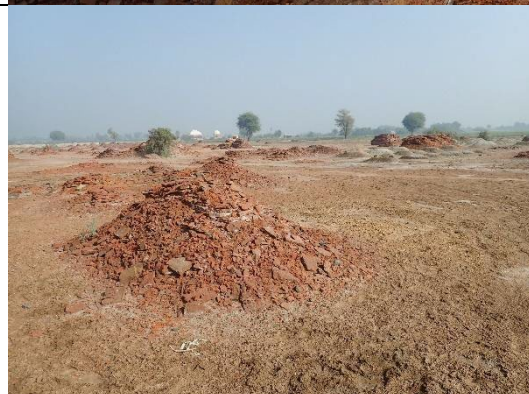
Fig.4 Brick tombs spread out around it. The collapse is remarkable.

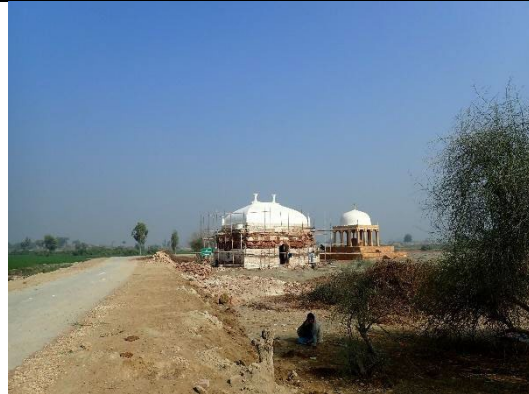
Fig.5 The mausoleum on the right side of the photo was restored after the dome collapsed due to the 2022 flood.

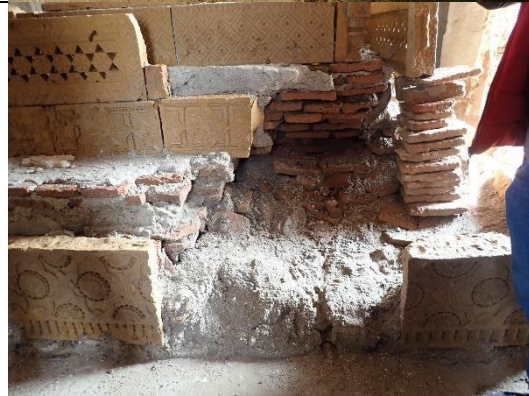
Fig.6 Fig. 5 Lower part of the tomb enshrined in the mausoleum on the left. Salt weathering is significant.

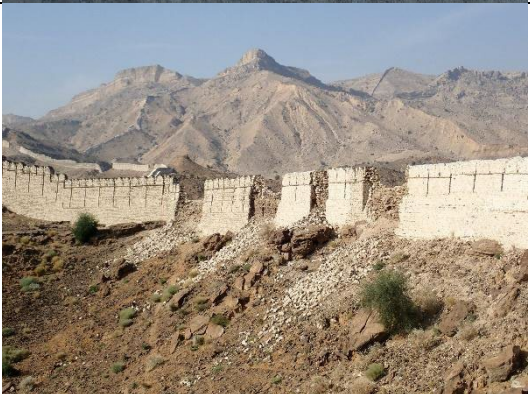
<p>Fig.3 Collapsed condition of the castle wall. Scattered white limestone from the collapsed area indicates that the area had been restored.</p>

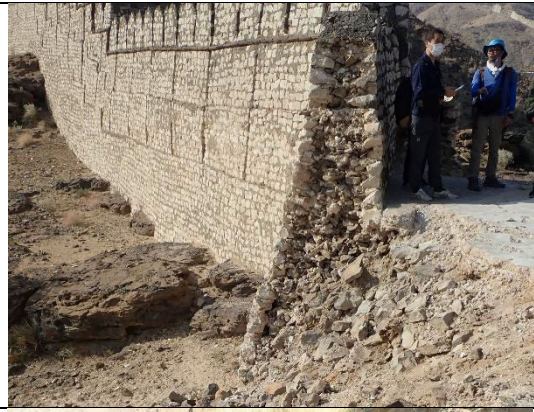
Fig.5 A section where the wall body is constructed of limestone or other gravel and mud, and limestone is used for decorating purposes.

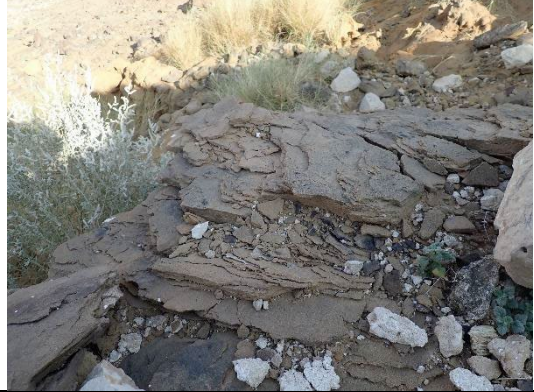
Fig.6 Sandstone layers that make up the ground. It is fractured into plates.

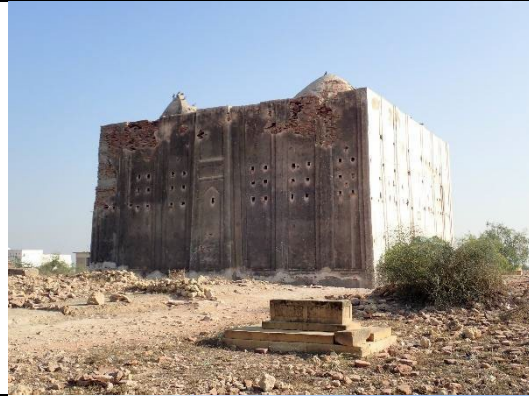
Fig.1 A mausoleum located in Makli. It is still used by local residents as a place of worship.

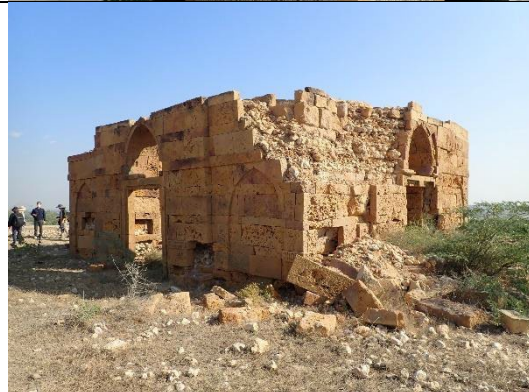
The World Heritage Site of Makli, a vast ruins site, was located on higher ground than its surroundings, so it was not flooded during the 2022 floods. However, strong rainfall caused some buildings to collapse. Secondary damage included a fire in which a large amount of overgrown weeds burned after the rainfall.

Fig.3 The building is mainly constructed of stonework; strong rainfall during the flood of 2022 caused the building to collapse.

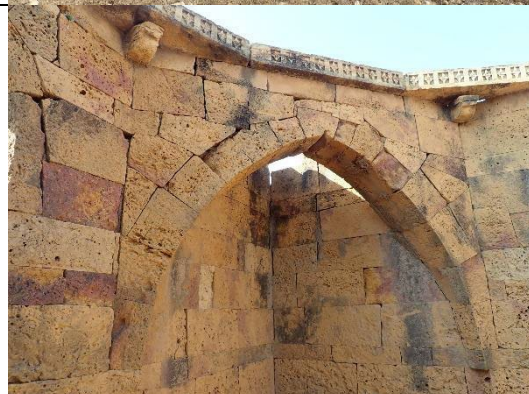
Fig.4 Stonework structure.

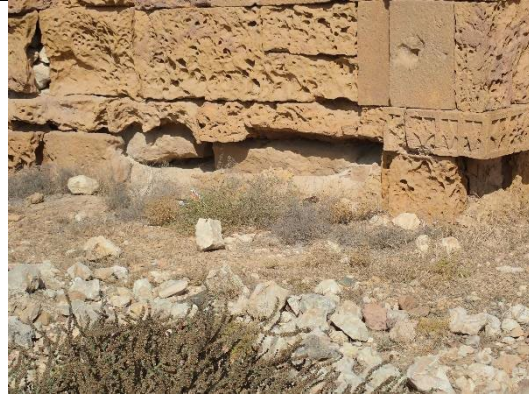
Fig.6 Salt weathering observed in the lower part of stonework structures.
